DOCKET NOS. 50-266 AND 50-301
LICENSEE EVENT REPORT 266/2000-010-00
MANUAL REACTOR TRIP DUE TO CONCERNS FOR DIVER SAFETY
POINT BEACH NUCLEAR PLANT UNIT 1

Point Beach Nuclear Plant, Unit 1

Manual Reactor Trip Due to Concerns for Diver Safety

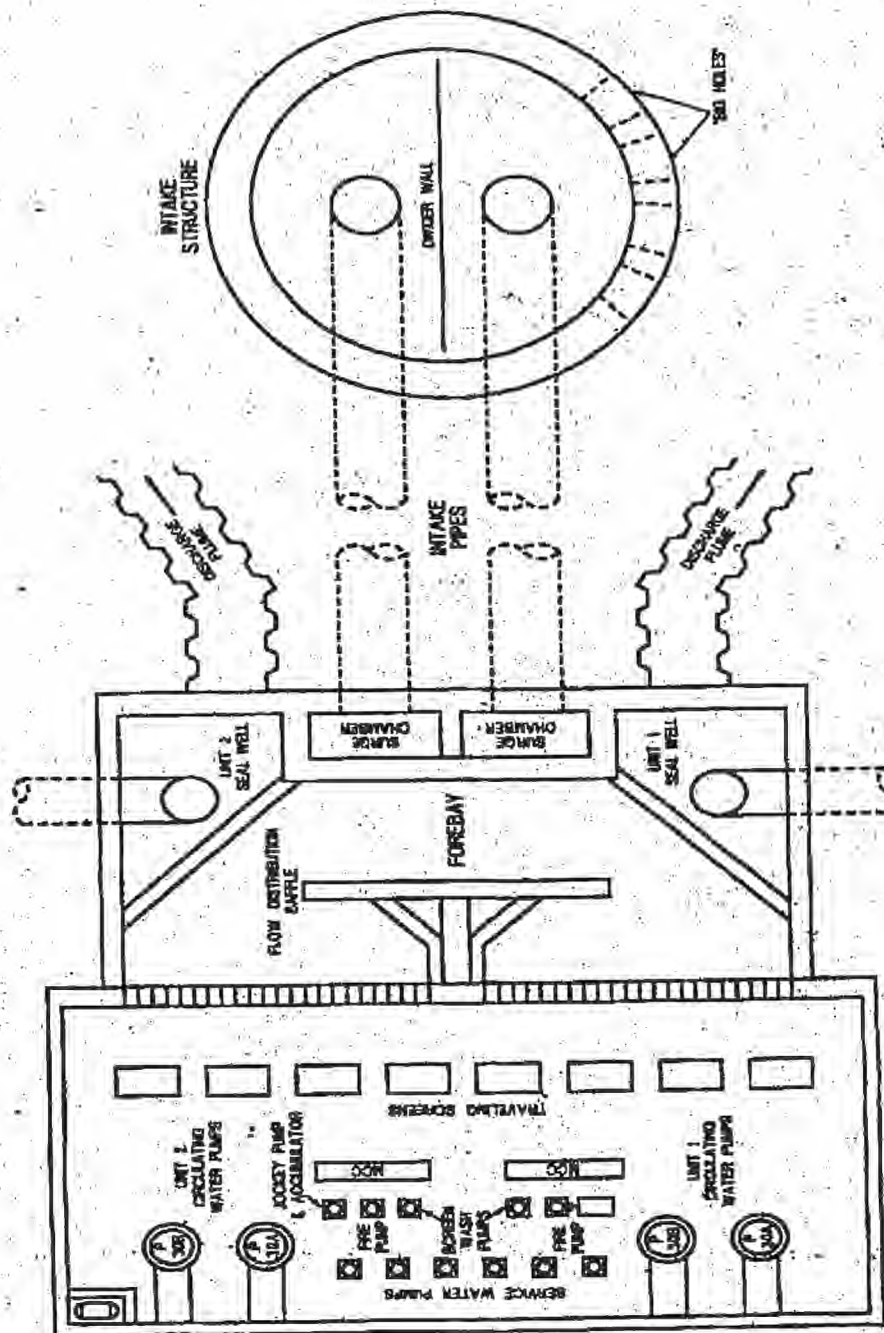
FIGURE 11.7.1 INTAKE AND PUMP HOUSE

The circulating water system consists of the intake system pump house facility, circulating water pumps, traveling screen and screen wash system, main condensers, vacuum priming system, discharge flumes and interconnecting piping and valves (See Figure 11.7.1 attached). The circulating water intake system is common; but once in the pump house the system splits to Unit 1 and Unit 2 components. The intake system consists of an open-ended, cylindrically-shaped structure constructed of steel piling and limestone rock located 1750 feet off-shore. Two 14 foot diameter pipes connect the intake structure to the forebay of the pump house facility. The pump house facility consists of two intake surge chambers, a common forebay, pump bay and two discharge seal wells. The pump bay is divided into two sections with two circulating water pumps, three service water pumps, one screen wash pump and one fire pump taking suction from each section. Fourteen foot diameter motor-operated butterfly valves isolate the intake surge chambers from the forebay and discharge seal wells. Fourteen foot diameter motor-operated butterfly valve are also provided to isolate the seal wells from the respective discharge flumes. The arrangement of isolation valves permits reversing flow through either inlet pipe during winter operations to recirculate warm circulating water out to the intake structure to prevent freezing. The entrance to each pump bay section is partitioned into four separate passageways each containing traveling water screens to remove small debris. After passing through the screens, the water enters the pump bay section.
